TECHNICAL REPORT ARCCB-TR-03002

**APPLICATION OF LASER PULSE HEATING  
TO SIMULATE THERMOMECHANICAL  
DAMAGE AT GUN BORE SURFACES**

**US ARMY ARMAMENT RESEARCH,  
DEVELOPMENT AND ENGINEERING CENTER**  
Close Combat Armaments Center  
Benét Laboratories  
Watervliet, NY 12189-4000

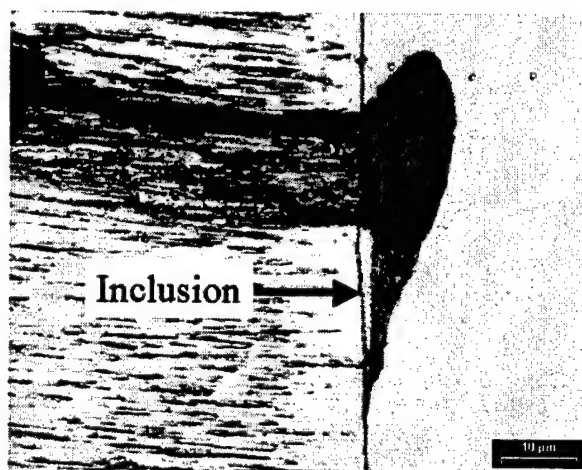
Figure 4. Example of cavitation extending into a large void under laser pulse heating of the sputtered chromium specimen. In this case an inclusion evidently enhanced the process.

Figures 3 and 4 show several of the larger cavitations that occurred in laser pulse heated specimens that were coated with sputtered chromium. Twenty pulses of approximately  $1 \text{ J/mm}^2$  were applied. The asymmetry of the void observed in Figure 4 was caused by the long, thin surface inclusion visible at the chromium/steel interface. Similar surface inclusions are seen elsewhere along this interface and were probably introduced during surface grinding. The asymmetric shape of the large void in Figure 4 is due to the lack of adhesion between the inclusion and the steel, which allowed the steel to pull away from the inclusion during the cavitation process. On the other hand, the coating-to-inclusion adhesion is expected to be good because that inclusion surface was exposed to the sputter-cleaning process prior to deposition. We observe similar disbonding effects at cavitation sites in specimens where poor adhesion exists between the coating and the steel.

The magnitudes of the plastic strains that occurred at the surfaces of the cavities in Figures 3 and 4 are unusually large. If one assumes, conservatively, that the cavities in these figures start flat with a width equal to the chromium crack widths, then we are observing strains in 500 to 800% range, indicative of high strain rate superplasticity. The essential conditions for high rate superplasticity are small grain size and high temperature (greater than 0.5 melting point) (ref 12). Both are present in the heat-affected zone since the grain size is submicron. Given that superplasticity is likely to be present in the heat-affected zone, the flow stresses will actually be substantially less than the yield strengths assumed in the discussion of the processes associated with Figure 9.
